MICROSCOPIC EVALUATION OF A POLYIMIDE (PMR15)-GRAPHITE COMPOSITE

Jeffrey J. Fedderly and Joseph M. Augl
Naval Surface Weapons Center

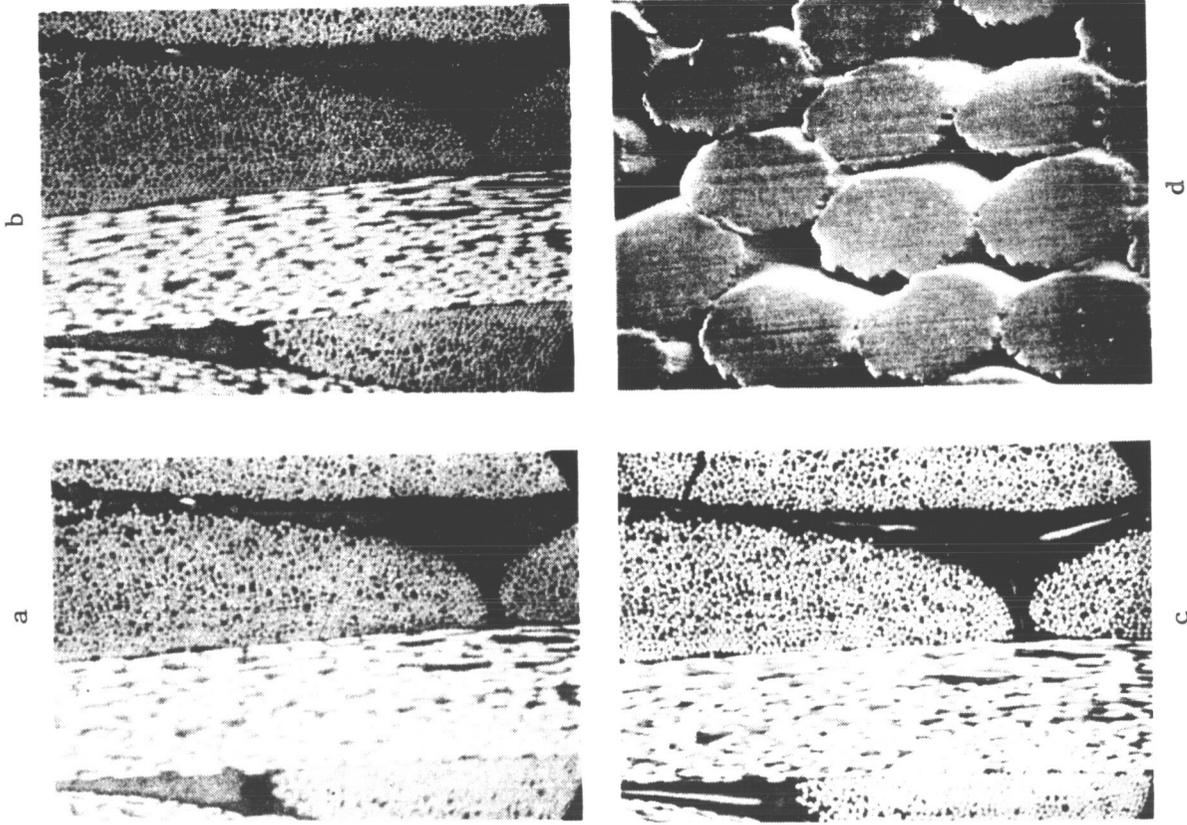
8 Ply Test Panel Two material samples were observed and photographed along the cross section oriented in the 0° direction. The first observation of the material after the beginning the exposure was made after 17 hours of exposure. The couple of very thin cracks which had been present initially had now widened slightly. The only other noticeable change was that in the regions between 90° fibers (perpendicular to the surface) very shallow depressions in the resin could be seen (see fig. 4a) indicating a slight degradation and loss of resin. After 38 hours of exposure no other change or damage was observed except for a slight increase in the loss of resin from the surface. The first new crack in one sample did not appear until after 169 hours. Only after 258 hours of exposure did several cracks appear in both specimens (see fig. 5). In every case the cracks are located in the 90° fiber areas and run transverse to the 0° direction, never along it. The lengths of the cracks are dictated by the width of the 90° fibers bundles. In most every case the crack runs the entire width of the 90° fiber areas (about 0.35mm. maximum), but never beyond into 0° fiber areas where cracks would have to cut through carbon fibers in order to propagate. The few cracks which had developed earlier had now widened noticeably. The loss of resin from the surface still appeared to be continuing slowly. After 324 hours of exposure many more cracks had formed and there was continued lengthening and widening of old cracks. The maximum widths of the cracks was approximately 13μ. The depressing which were due to resin loss were only a few microns deep (see fig. 4d) and thus this damage seems minimal.

Figure 4. - Loss of resin from composite surface.

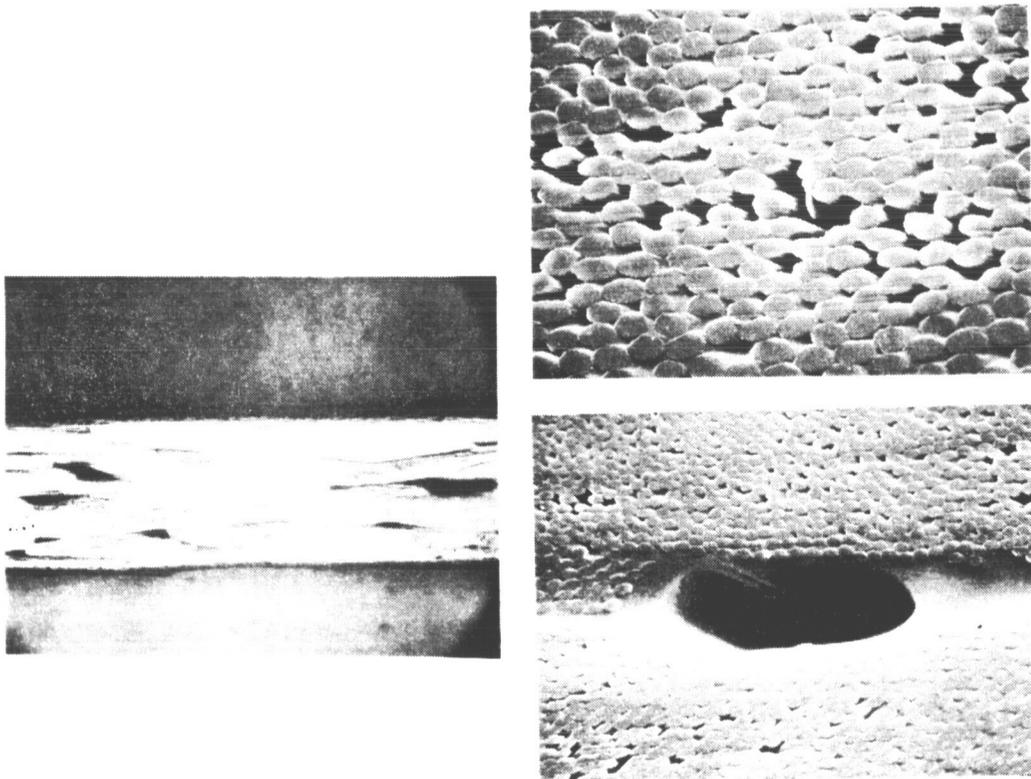
The initial condition of both sets of specimens (4 and 8 ply) appeared to be good. Only a few hairline cracks were observed prior to exposure. The 8 ply material has virtually no voids. The rare voids that were found were always located in resin pockets, between bundles. The 4 ply material has nearly a 3% void content. In addition to the larger voids found in resin pockets, areas within the fiber bundles were found which contained many small voids (see fig. 3).

Figure 3. - Initial condition of 4 ply material.

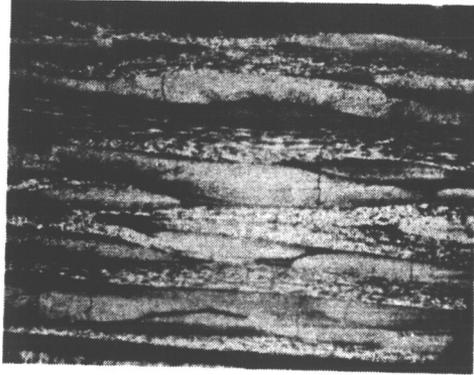
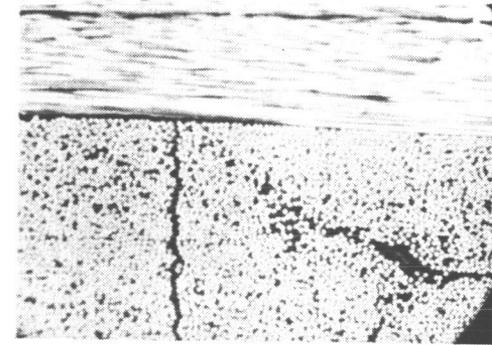
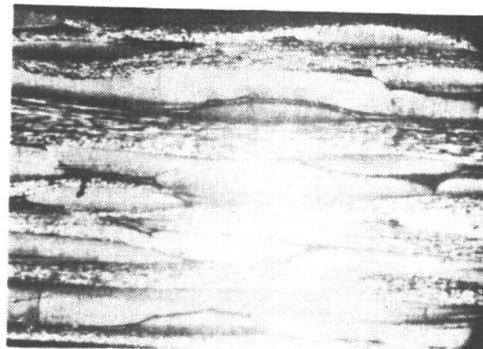
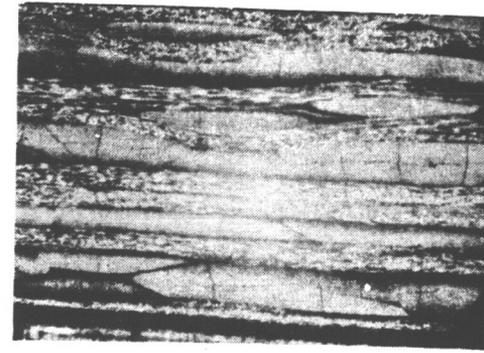
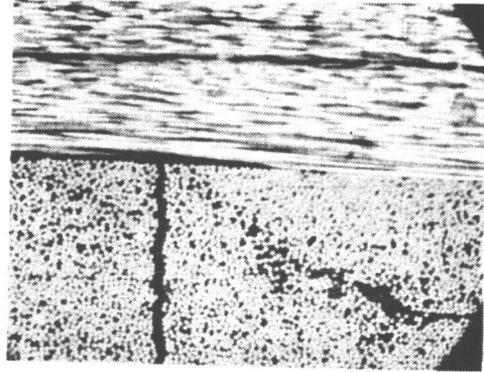
After 391 hours of exposure or at 473°F the cross section appears to be heavily cracked and damaged (see fig. 6), but the real extent of the damage was not known until the depth of the cracks into the interior was determined. In order to determine the depth of the cracks into the material, the cross section of the specimen was gradually ground down and periodically examined for the extent of cracking.

After about 0.1mm. had been ground down most of the cracks, which had formed during the exposure, had been removed. Thus most all the cracks observed along the cross section were less than 0.1mm. deep. After 0.3mm had been ground down from the surface only a couple of cracks still remained and these were two cracks which were present in the material before exposure began.

Figure 6. - 8 ply specimen after 391 hours of exposure at 473°F.

Figure 5. - 8 ply specimen after 258 hours of exposure at 473°F.

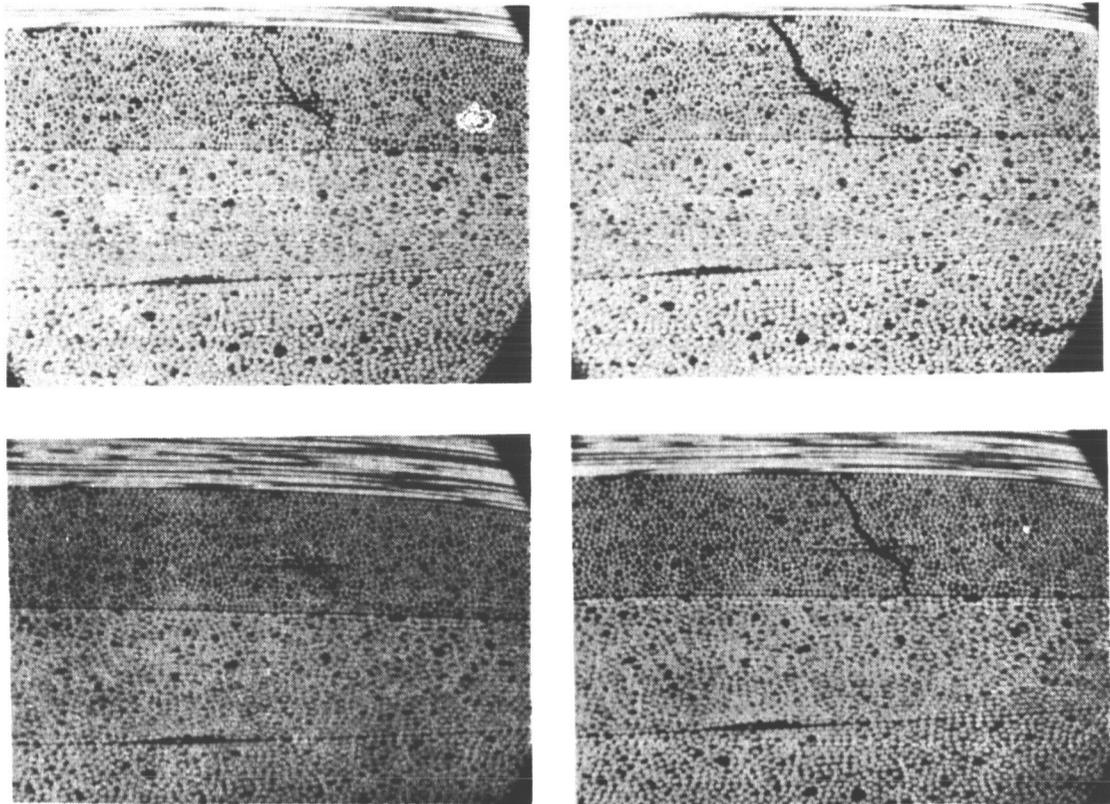
The cracking behavior of the 4 ply material was different than that of the 8 ply material in several ways. First, the onset of surface cracking appeared sooner in the 4 ply panel than in the 8 ply panel. After only 50 hours of exposure a couple of cracks were observed in 90° fiber areas. From 50 to 213 hours of exposure there was a slow, steady increase in the number of surface cracks that did not appear in the 8 ply material until after 108 to 170 hours of exposure. As in the 8 ply material, cracks started as being short and thin and grew with additional exposure. In this material the maximum width of the 90° areas is smaller than in the 8 ply composite thus the maximum length of cracks, which run transverse to the 0° direction in the 90° fiber regions, are shorter (0.20mm) than in the 8 ply composite (0.35mm). The cracks grew to maximum widths of about 7μ. Also the cracks generated in the 4 ply material, almost without exception, originated in areas containing a high concentration of small voids intermixed in between the 90° fibers (see fig. 7). The 8 ply composite did not have void filled areas such as this.

Figure 7. - Crack formation in 4 ply composite.

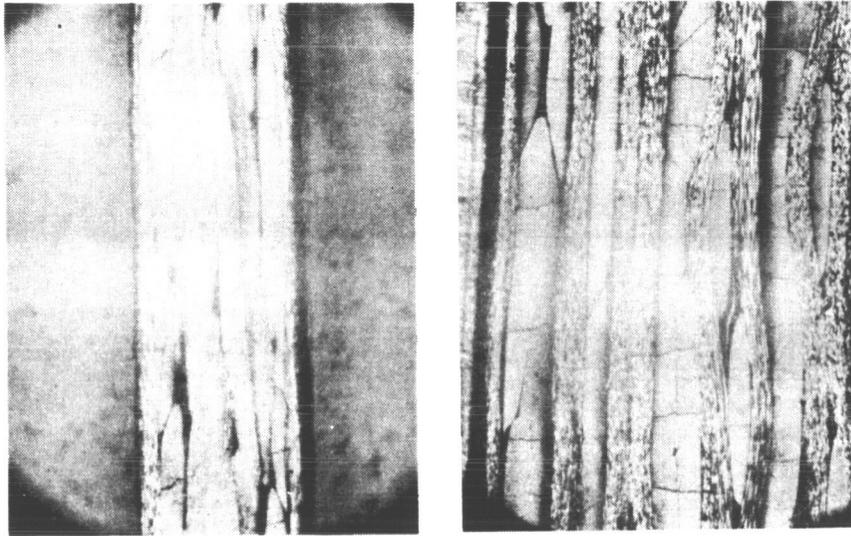
Another difference between the two materials is that, although the 4 ply composite began crack formation earlier in the exposure period than did the 8 ply material, the 4 ply specimens do have a noticeably smaller final crack density than do the 8 ply specimens (see fig. 8). Also noticeable in figure 8, is that the cracks in the 4 ply material have formed only in the 90° fiber strand areas, which are in the outer two plies. As with the 8 ply material, one would not expect to crack formation in the 0° strands at the 0° cross section. Yet, it might be expected that cracks would form in the ± 45° fiber regions. Cracks could form and propagate between fibers in the transverse direction and still be observed along the 0° cross section, yet no cracks are found in these areas.

Figure 8. - 4 and 8 ply specimens following exposure at 473°F.

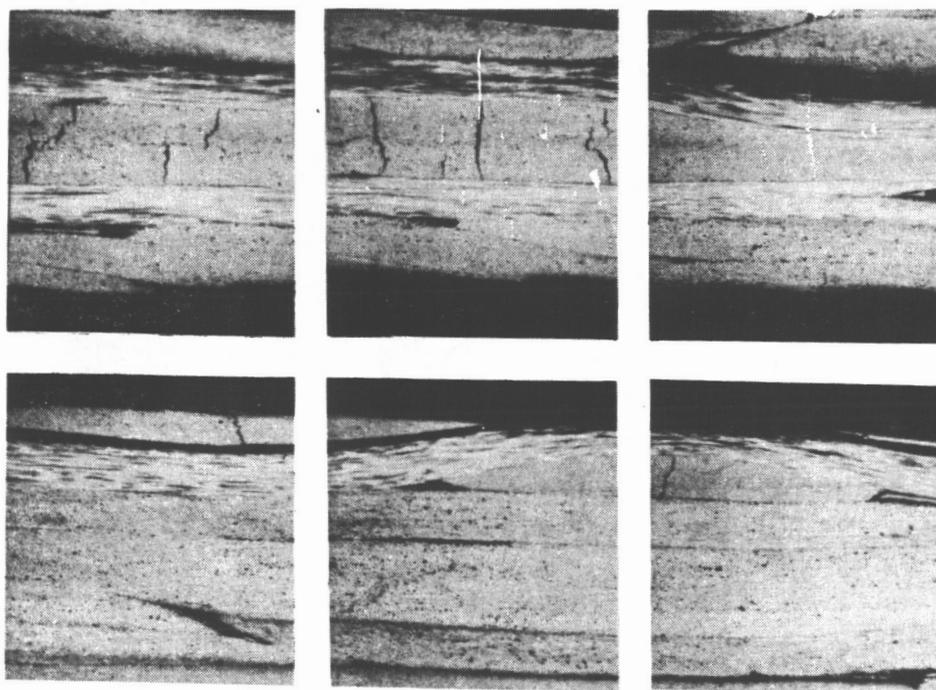
In order to determine whether the stresses as a whole are significantly less in the interior plies of the 4 ply material than in the 8 ply material or whether the stresses which produce cracks are governed by the orientation of the fibers with respect to the cross section, a new specimen was cut which had 4 cross-sectional surfaces prepared for observation. One side was cut along the 0° axis and perpendicular to the 90° fibers (as before), another was cut along the +45° axis and perpendicular to the -45° fibers, another was cut along the 90° axis and perpendicular to the 0° fibers, and the last surface was cut along the -45° axis and perpendicular to the +45° fibers. As this specimen was subject to 473°F exposure, it became evident that cracking occurred only in regions where the fibers were perpendicular to the exposed cross-sectional surface. Areas with fibers in the -45° direction, now produced cracking behavior when the cross section was cut in the +45° direction (see fig. 9). Like, this occurred in areas of +45° fibers with a -45° cross-sectional surface (see fig. 10).

Figure 9. - 4 ply composite following exposure at 473°F.
(Top: Along +45° axis. Bottom: Along 90° axis.)

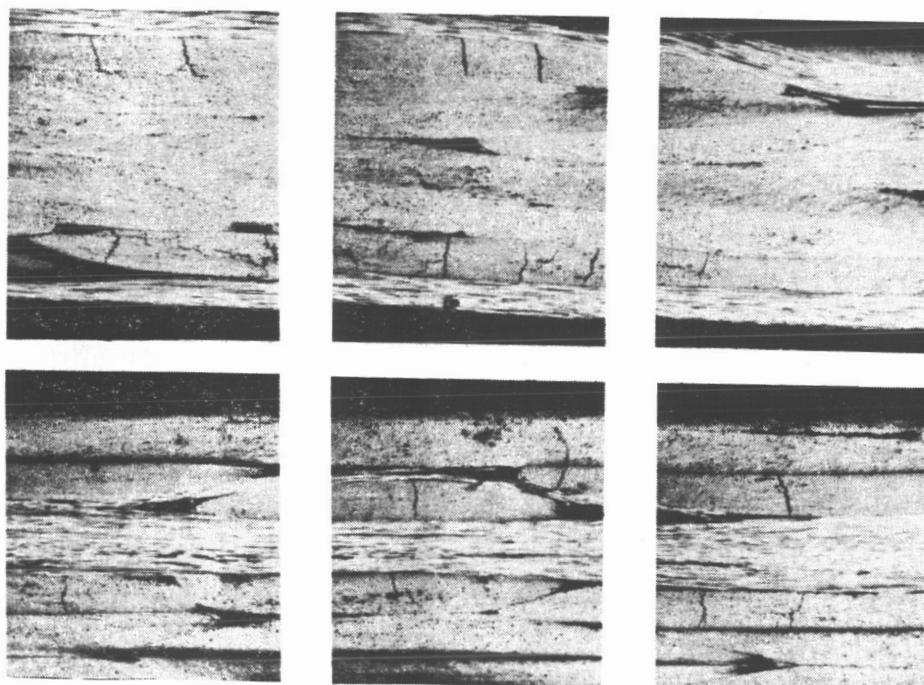
The cross section which was cut along the +45° direction showed the greatest amount of cracking. In this cross section the -45° fiber areas from both of the inner plies are adjacent to each other and perpendicular to the surface. Many of the cracks extended across the full width of the combined -45° fiber area (see fig. 9). The -45° area is bounded on both sides by the +45° strands whose fibers run perpendicular to the -45° fibers and only the axis of the cross section. The cross section with the least number of cracks is the one cut along the 90° direction. Here the 0° fiber regions are perpendicular to the surface and are in the outermost regions of the specimen. The other side of the 0° fiber area is bounded by a 90° fiber region (see fig. 9). The only cracks found during the exposure were located in 0° fiber areas where the 0° and 90° fiber strands had crossed over, resulting in the 0° bundle being shifted from the outside of the specimen to the interior and vice-versa for the 90° bundle. No cracks were formed during exposure in the areas where the 0° fibers were in the outermost portions of the material. The couple of cracks in this region, as seen in figure 9, were present before exposure began. The cross sections which were oriented along the 0° and -45° directions and which had 90° and +45° fibers perpendicular to their respective surfaces exhibited an intermediate amount of crack formation. The strands, in which cracking occurred were bounded on one side by fibers running perpendicular to them along the axis of the cross section and on the other side by bundles oriented 45° from the axis of the cross section (see fig. 10).

Figure 10. - 4 ply composite following exposure at 473°F.
(Top: Along 0° axis. Bottom: Along -45° axis.)

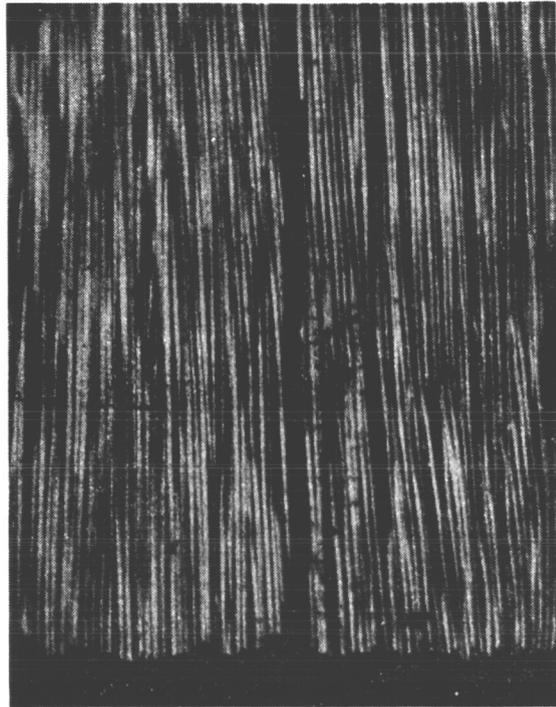
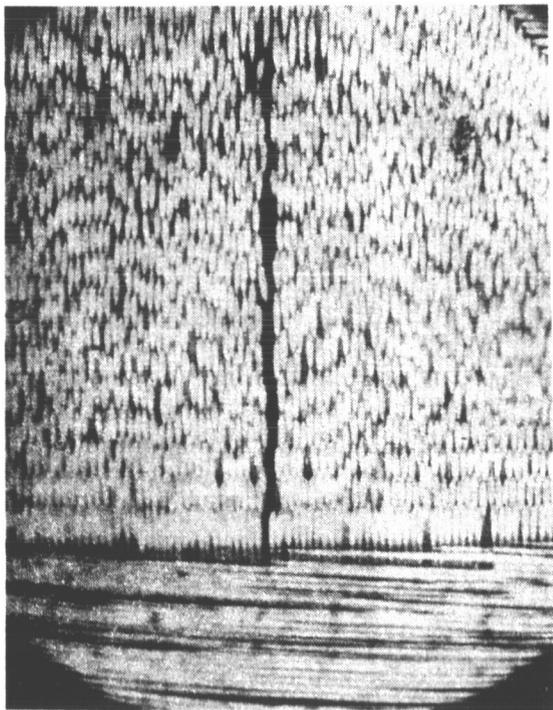
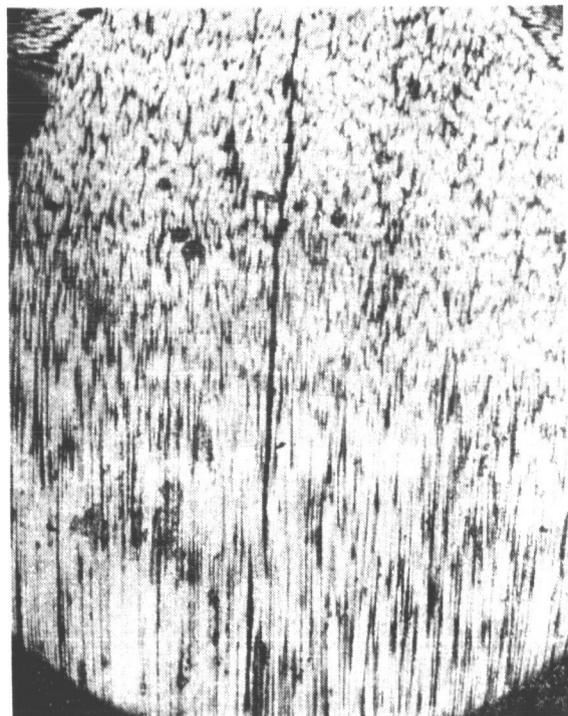
After the exposure was completed it was also noticed that cracks had formed along the outside surfaces of the 4 ply specimen as well as the cracks observed along the cross sections. Since these cracks were more difficult to observe and less prevalent than the cross-sectional ones, they were at first unnoticed. These cracks run along the length of the fibers found on the outside of the material. These cracks are long compared to the cracks in the cross section, whose lengths are limited by the widths of the perpendicular fiber bundles. The longest cracks observed were only about 3mm. long. Close-ups of a few of these cracks can be seen in figure 11. A sketch of the crack arrangement on the outer surface is shown in figure 12. At the outer surface the 0° fibers are dominant so most of the cracks are also oriented in that direction. Cracks are also found perpendicular to these in the regions where the 90° strands have crossed over in the weave and are on the outside.

Figure 11. - Cracks along the outer surface following exposure at 473°F.

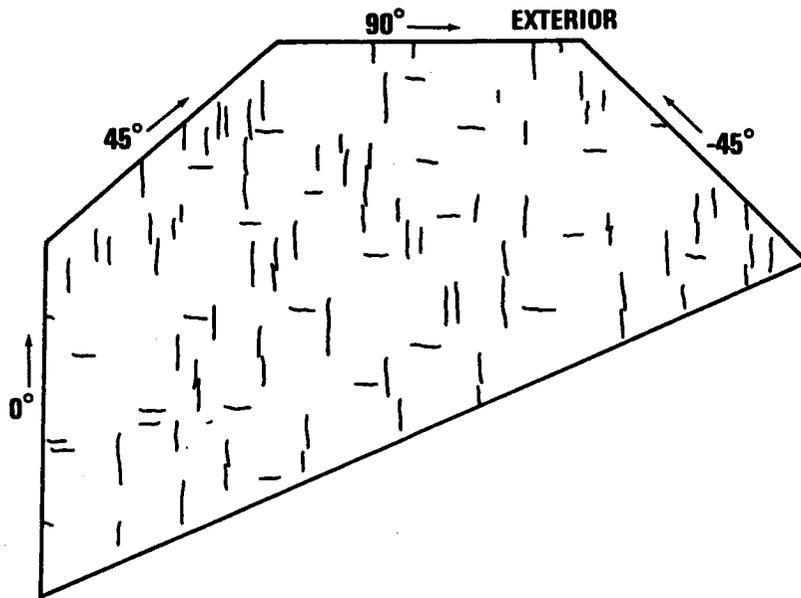
Figure 12. - 4 ply specimen after 400 hour exposure at 473°F.

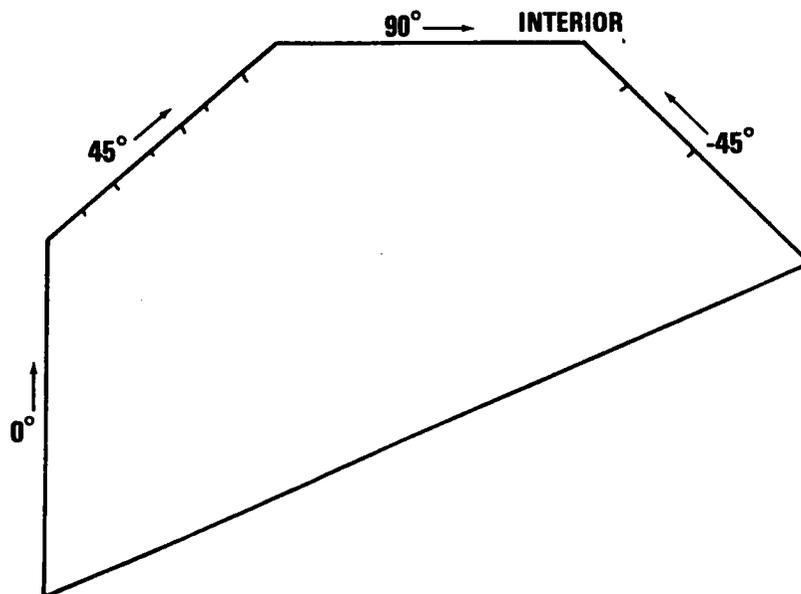
Figure 13. - 4 ply specimen after 400 hour exposure at 473°F.

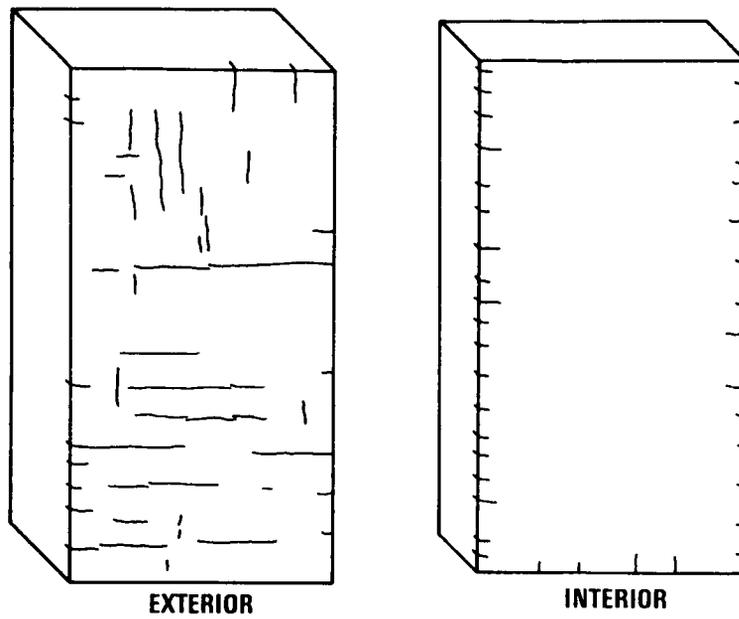
The entire polished outer surface of the other specimen exposed to 550°F was examined and its crack pattern carefully sketched (see fig. 14). The surface appears very similar to the 4-ply material following 473° exposure. The longest of the cracks are approximately 3.5mm. long and the crack density is comparable to that of the 4 ply specimen. As with the 4 ply material, the surface was ground down in order to determine the extent of damage to the interior of the material. Once approximately 0.18mm. had been removed from the original thickness of the material (at the midpoint of the outer ply) all of the cracks had been removed except the short cracks at the cross-sectional surface. Along with the 4 ply material, this shows that crack formation is a surface phenomenon and does not effect the interior of the composite. Many cracks were formed on the outer surfaces, but were limited to just the outer half of the outside plies. The cross-sectional surface was also heavily cracked, but as can be observed from grinding down the specimens, most of the cracks are only about 0.3mm. deep into the material, with an occasional crack extending about 0.7mm. into the interior. These cracks are somewhat longer than the cracks formed during the 473°F exposure, yet the majority of the interior of the composite has been undamaged due to the 550°F exposure.

Figure 14. - 8 ply specimen after 400 hour exposure at 550°F.
